Wyre Infrastructure: Given the increased level of seal interest in the farm we were (and are) in the process of replacing some of these nets with the latest generation seal defence netting. This has led to the very unusual action of moving fish between pens within the farm to allow this additional infrastructure upgrade to occur. (noting that, wherever possible, handling of fish is an action we minimise on the ground of fish welfare)

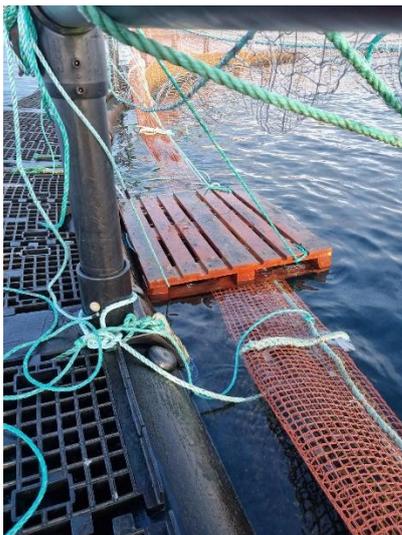
Photographs: No photographs were taken during this incident. The attached photograph is for reference and is the haul-out and lowered side wall netting used at the Wyre site with proven success in other situations.
